Case Report

Pneumothorax as a Complication of Arthroscopic Shoulder Surgery

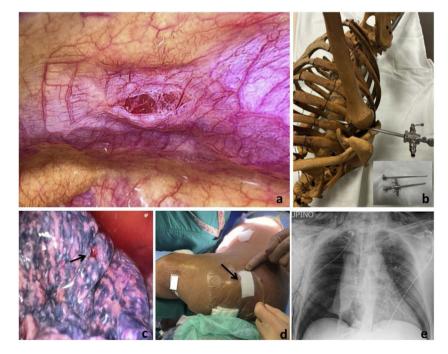
Fig. 1. (a) Parietal pleural lesion corresponding to the trocar entry point. (b) Simulation of the patient's position in the operating theatre and possible direction of the trocar for penetrating the thorax. Insert: working control of the arthroscope with the sharp trocar used. (c) Wound in the lung parenchyma located immediately below the chest wall injury (arrow). (d) Healing of the arthroscopy incisions. The arrow points to the trocar incision causing the pneumothorax. (e) Chest X-ray in AP showing complete right pneumothorax accompanied by subcutaneous emphysema.

to perform surgery by videothoracoscopy. Here we identified the origin of the leak as a deep rounded laceration in the posterolateral aspect of the right upper pulmonary lobe. This was of iatrogenic origin secondary to the insertion of the posterior arthroscopy trocar, and with an opening notch in the parietal pleura above it (Fig. 1a, c, and d). We repaired the laceration with a wedge resection using a surgical stapler.
